# The Numbers Don't Lie!

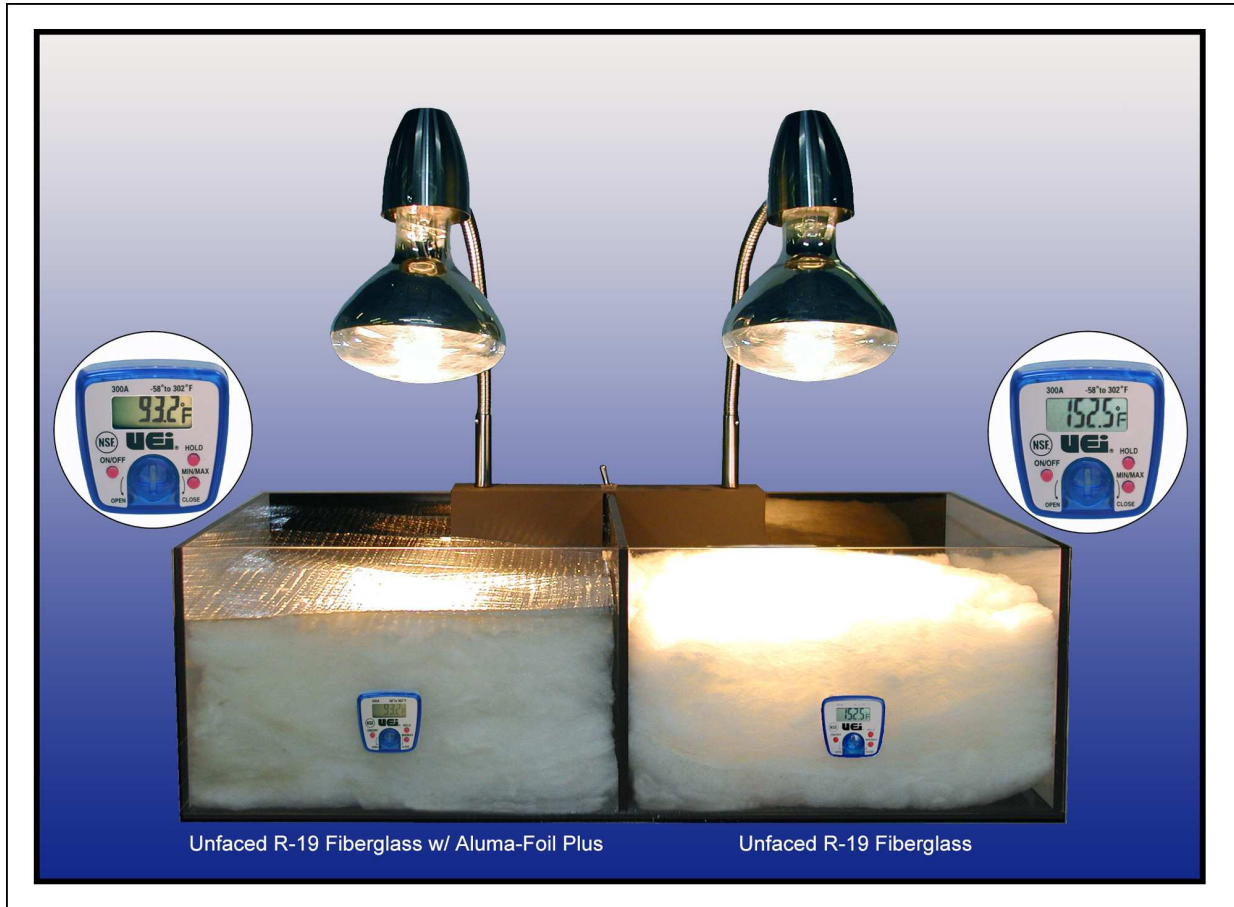
The test assembly above is used to demonstrate what happens to conventional mass insulation (right) when it is exposed, unprotected, to intense radiant heat, the most common cause of heat gain in an attic. This test demonstrates the importance of the proper use of a radiant barrier and a mass insulation (left). Results shown are for the hotbox assembly only. Actual performance in an attic would vary dependant upon; outside air temperature, method of installation, roof type, roof color, venting, etc.

Results are based on an 86°F ambient air temperature average. Above temperature readings were taken at the end of a six hour period. Results showed that the R-19 with Aluma-Foil Plus radiant barrier, was able to maintain a 6°F average above ambient air temperature. The side without radiant barrier maintained an average of 58°F warmer than that of the side with Aluma-Foil Plus.

58°F Average  
Temperature  
Differential !
